# Boys and Girls Club of the Hi-Line Preliminary Architectural Report

Havre, Montana

Montana CDBG Program - Spring 2016  
prepared for the City of Havre, Montana

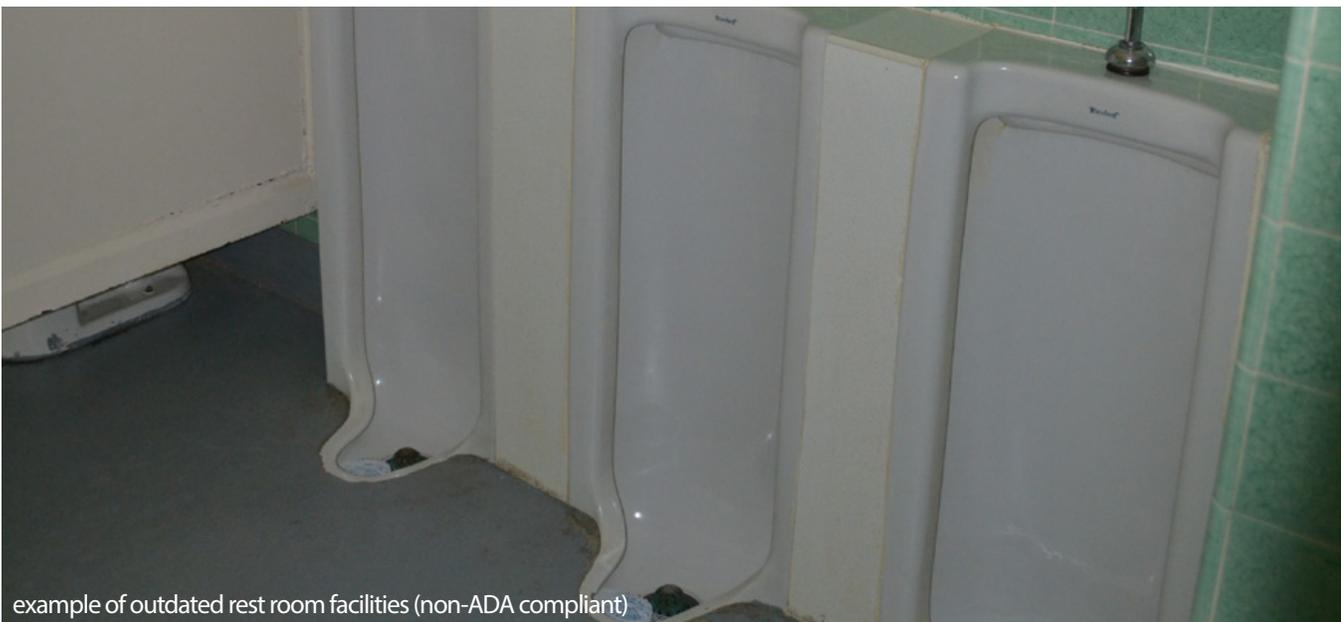
example of outdated rest room facilities (non-ADA compliant)

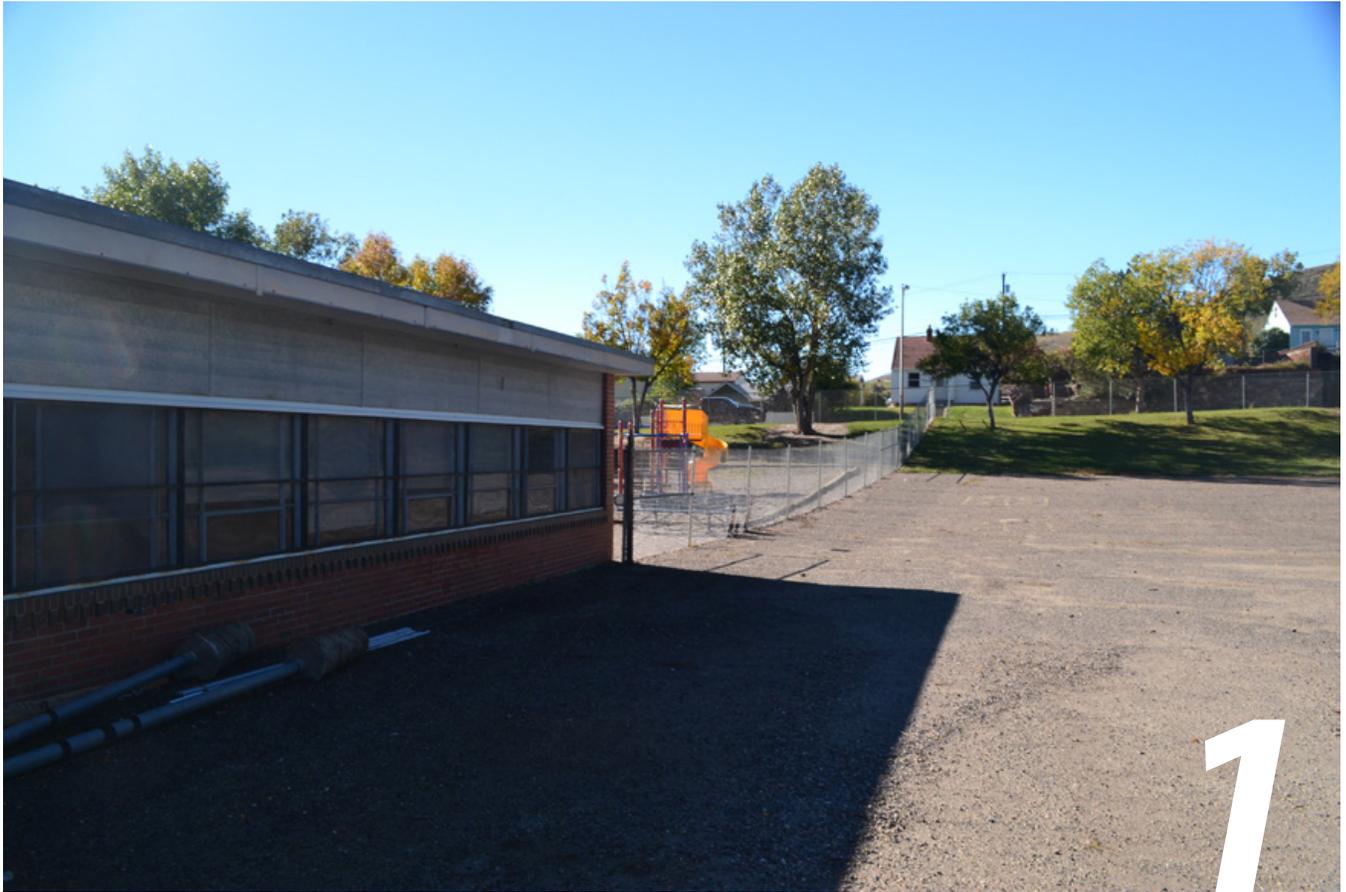
**Re-roof STEM / Power Hour space**

As outlined in the Health and Safety section of this report, the major past problem in need of remedy is a re-roof on the south wing of the building. A large portion of the ceiling/roof in the Teen Center collapsed due to water damage in 2015 and was temporarily repaired. A full re-roof with appropriate materials and detailing is recommended prior to another winter, as significant damage and risk could occur.

Remove the existing roofing and insulation. Replace with new insulation that meets energy standards. The roof will be replaced with a new roofing membrane system, with new flashing and trim. Any roof drainage issues will be mitigated.

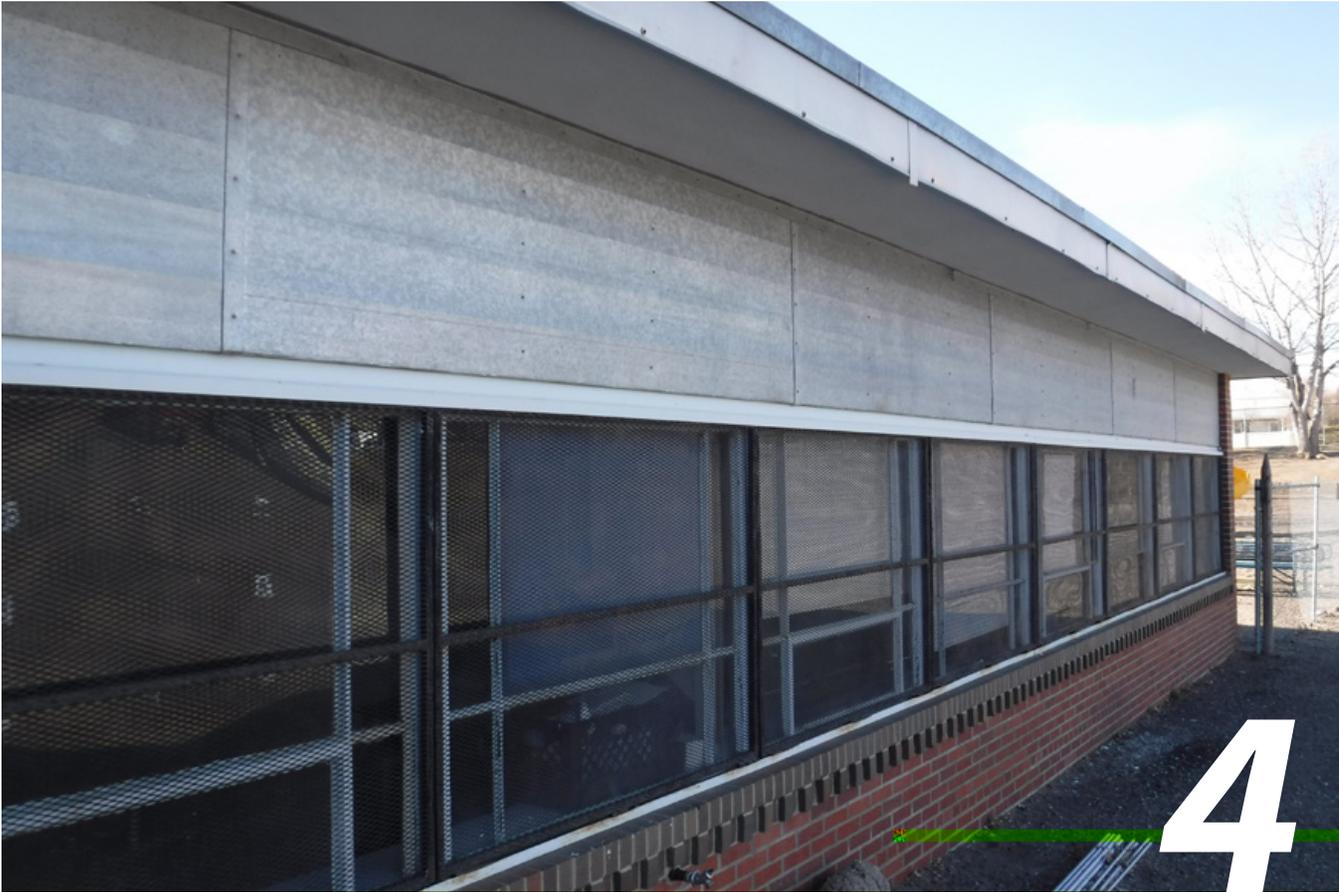
**Replace Teen Center Windows**

and extremely cold in the winter. Anyone familiar with the intense weather on the Hi-Line can attest that this is not conducive to learning or fun. A simple window replacement could greatly improve the experience and appeal of the Teen Center and help the Club reach a critical at-risk population of teenage students.

The Teen Center windows need replacement. If the general renovation of the Teen Center is not proceeded with, but the budget allows for the window replacement, then the windows could be a separate project. New energy efficient windows, flashing, sealant, etc. would be installed.

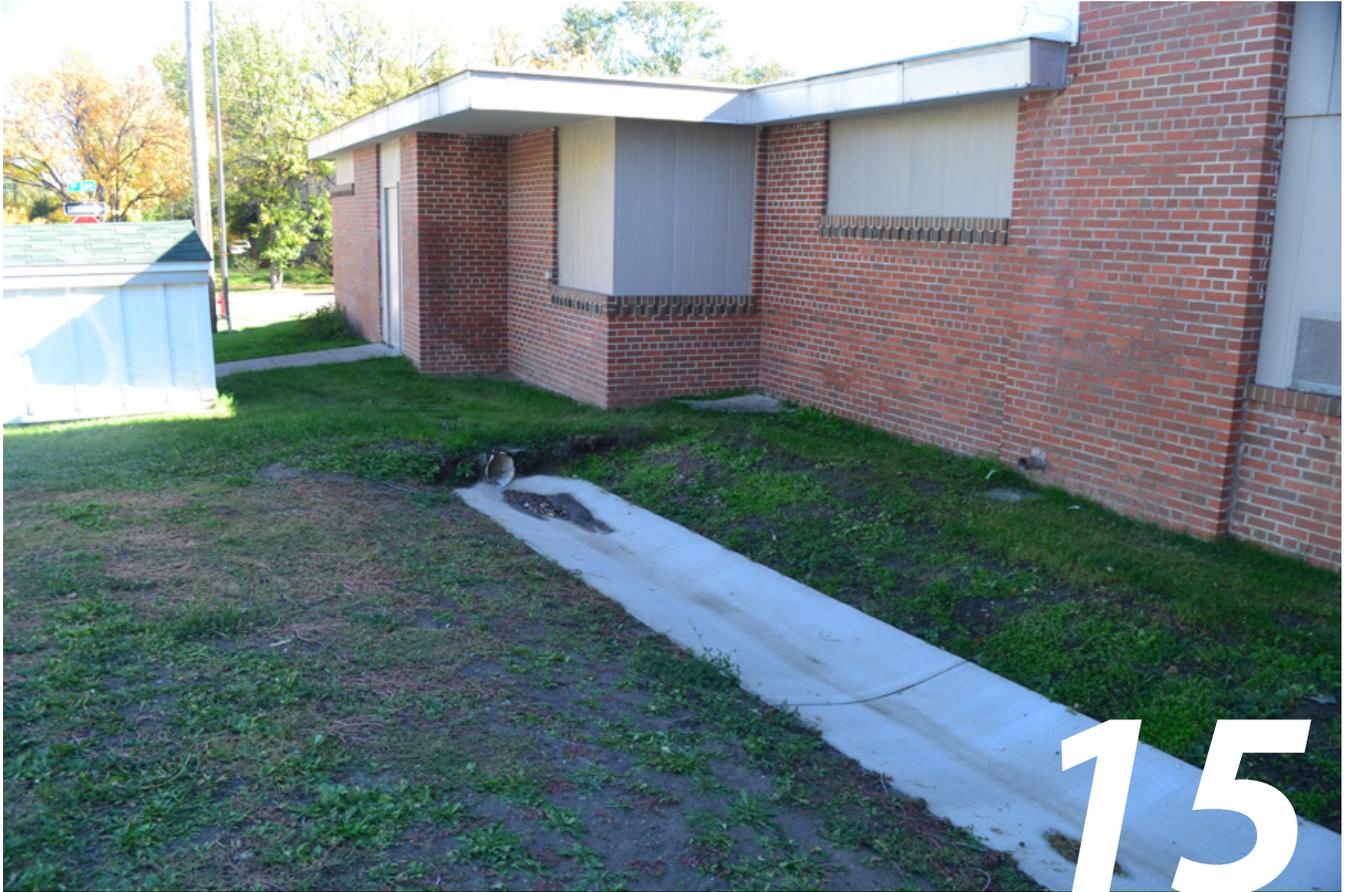
**Improve Entrance Drainage**  
Adjust entrance drainage near the drop off area.

The second largest historical issue is related to water runoff. While the site is now drained appropriately it receives large amounts of water from uphill properties throughout the winter and spring, and during storm events. Just uphill from the Club is Blue Pony Stadium, which encompasses a large coulee drainage area, contains a large parking area, and the School District also piles their removed snow there in the winter. These conditions create a significant amount of off-site water for the Club to deal with. A new drainage swale addresses some of the issue at the west and north sides of the building. However, the bulk of the water runs to the south and east of the building where the problem is compounded by the fact that the asphalt in the street has been built up so much that only an inch or two of the curb remains. This results in water coming onto the property and collecting, unfortunately, at the entrance ramp where busses drop kids off. Thus leading to an unpleasant and somewhat dangerous series of conditions, particularly in winter. While the Club cannot address the off-site issues put upon them, they can build a new curb and do some minor work to diminish its impact and increase safety.

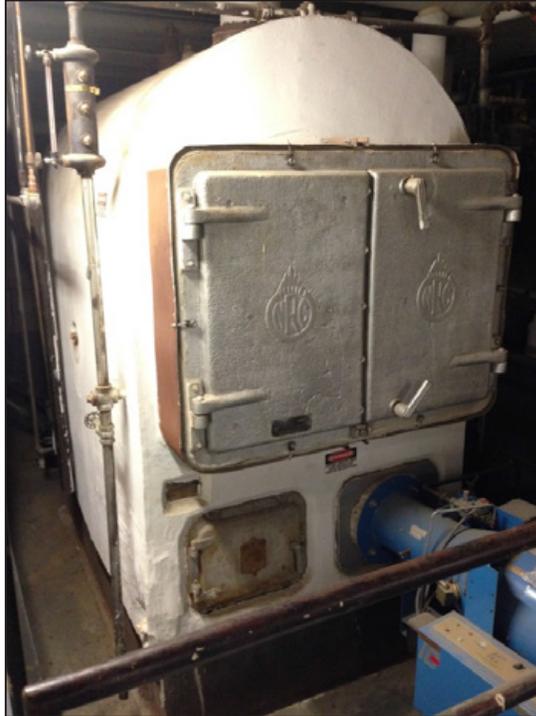
**Photo 1:** Boiler in basement. Asbestos caution labels on exterior of boiler. Asbestos in good condition.

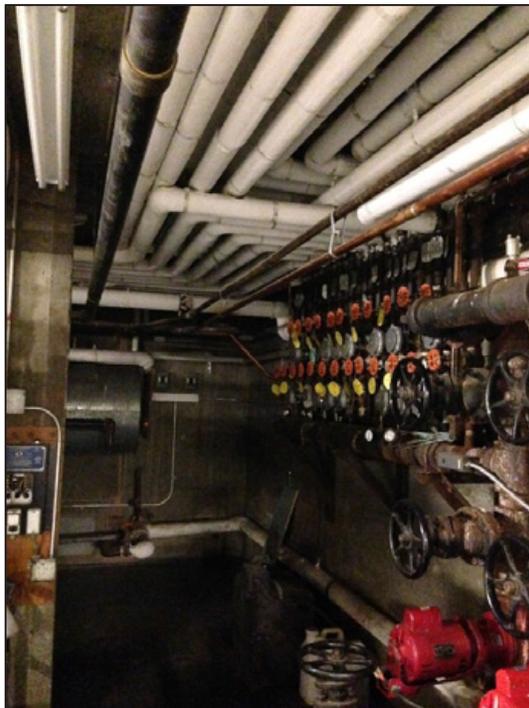
**Photo 2:** Boiler room with asbestos straight-pipe insulation. Approximately 20 insulated lines are shown.

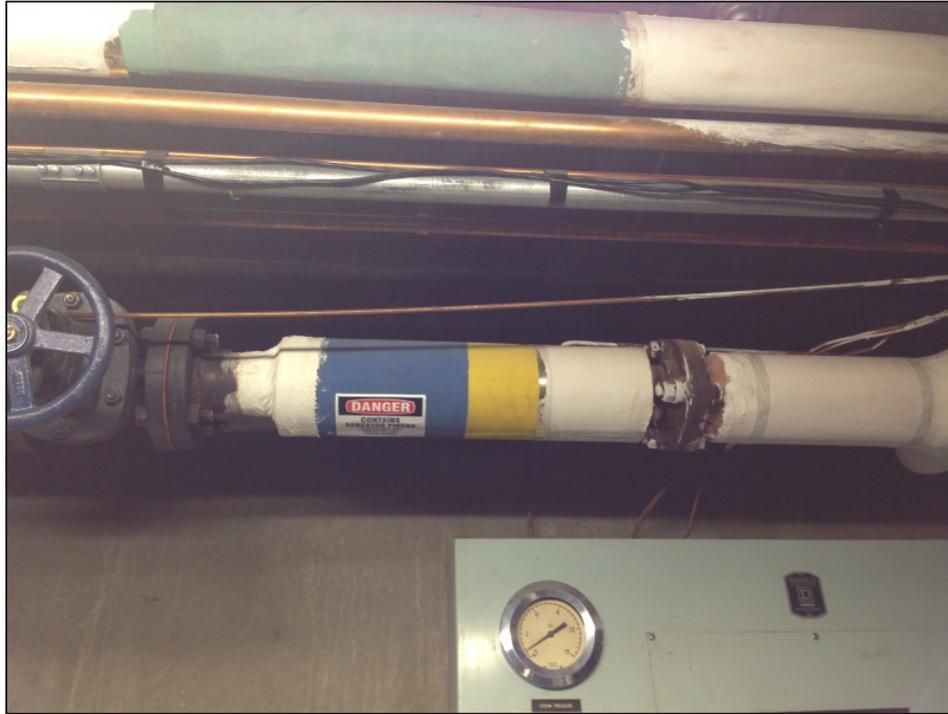
**Photo 3:** Warning label on asbestos straight-pipe insulation in boiler room.

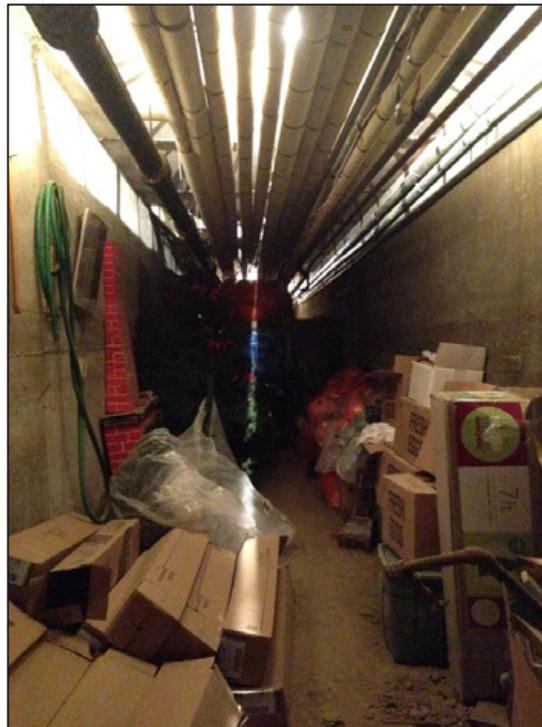
**Photo 4:** Interior pipe corridor with approximately 12 straight pipes of various sizes (2 to 6 inches). Asbestos insulation is in fair condition.

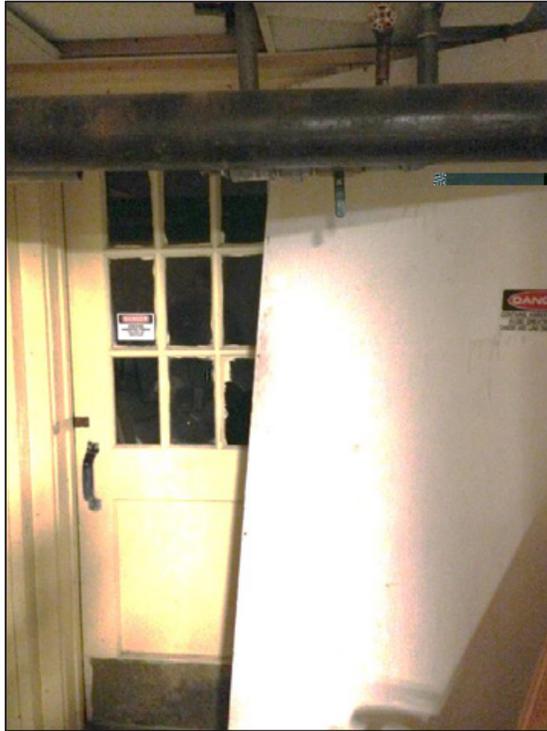
**Photo 5:** Door to the pipe corridor. Asbestos warning labels on doors.

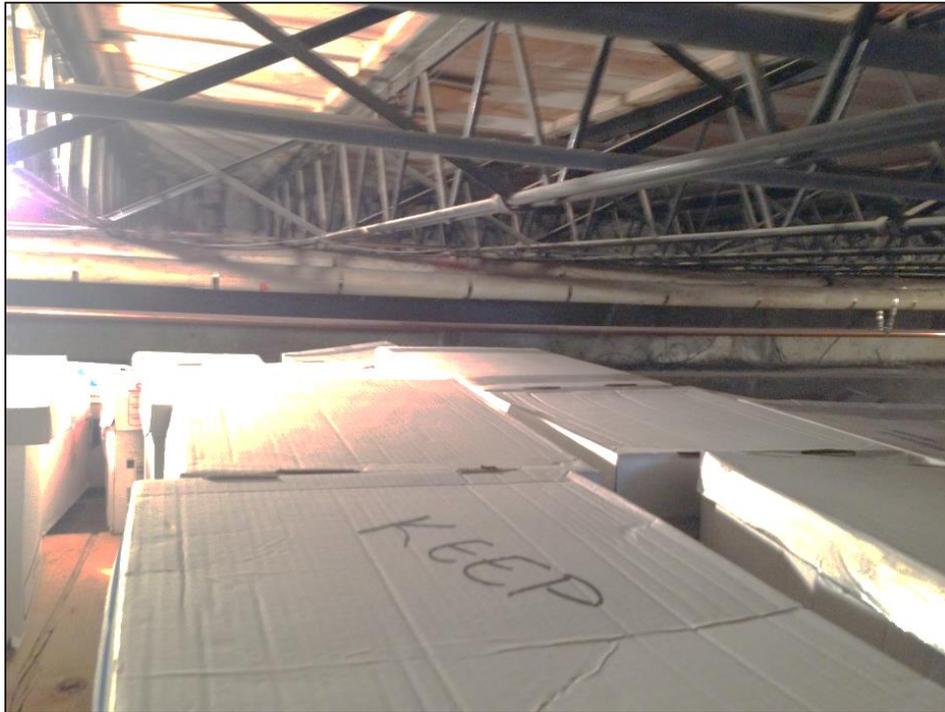
**Photo 7:** Storage space under stage with asbestos straight-pipe insulation. Approximately four pipes are present in fair condition. Folding chairs and files are stored in the room.

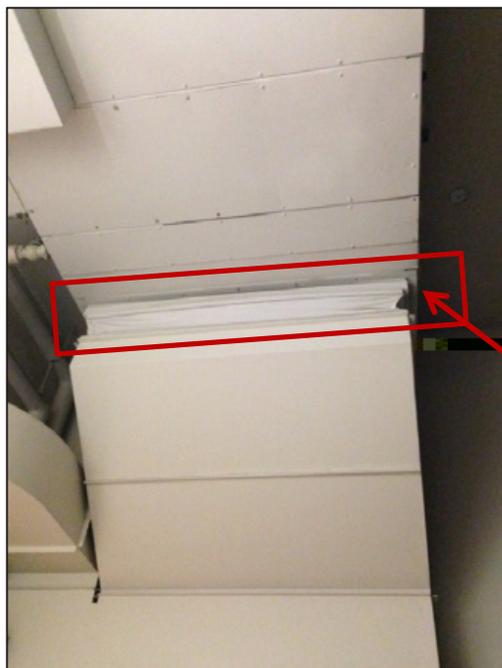
**Photo 8:** Vibration collar on heating unit in stage/gymnasium area. Sample not collected during this investigation, and the material is assumed to contain asbestos.

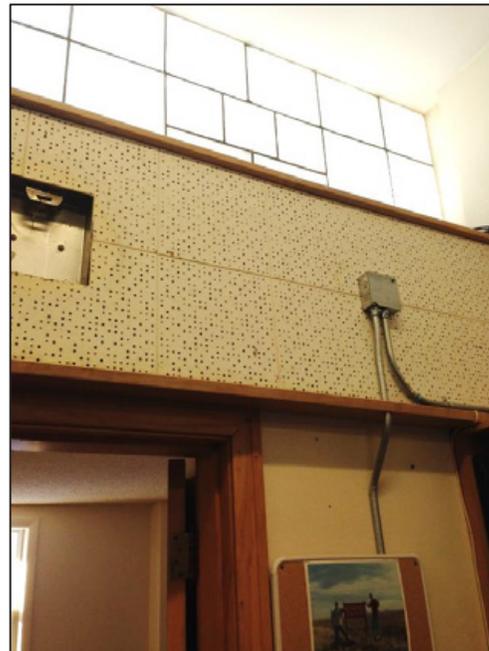
**Photo 10:** Fiberboard found to have non-asbestos adhesive.
