# Boys and Girls Club of the Hi-Line Preliminary Architectural Report

Havre, Montana

Montana CDBG Program - Spring 2016  
prepared for the City of Havre, Montana

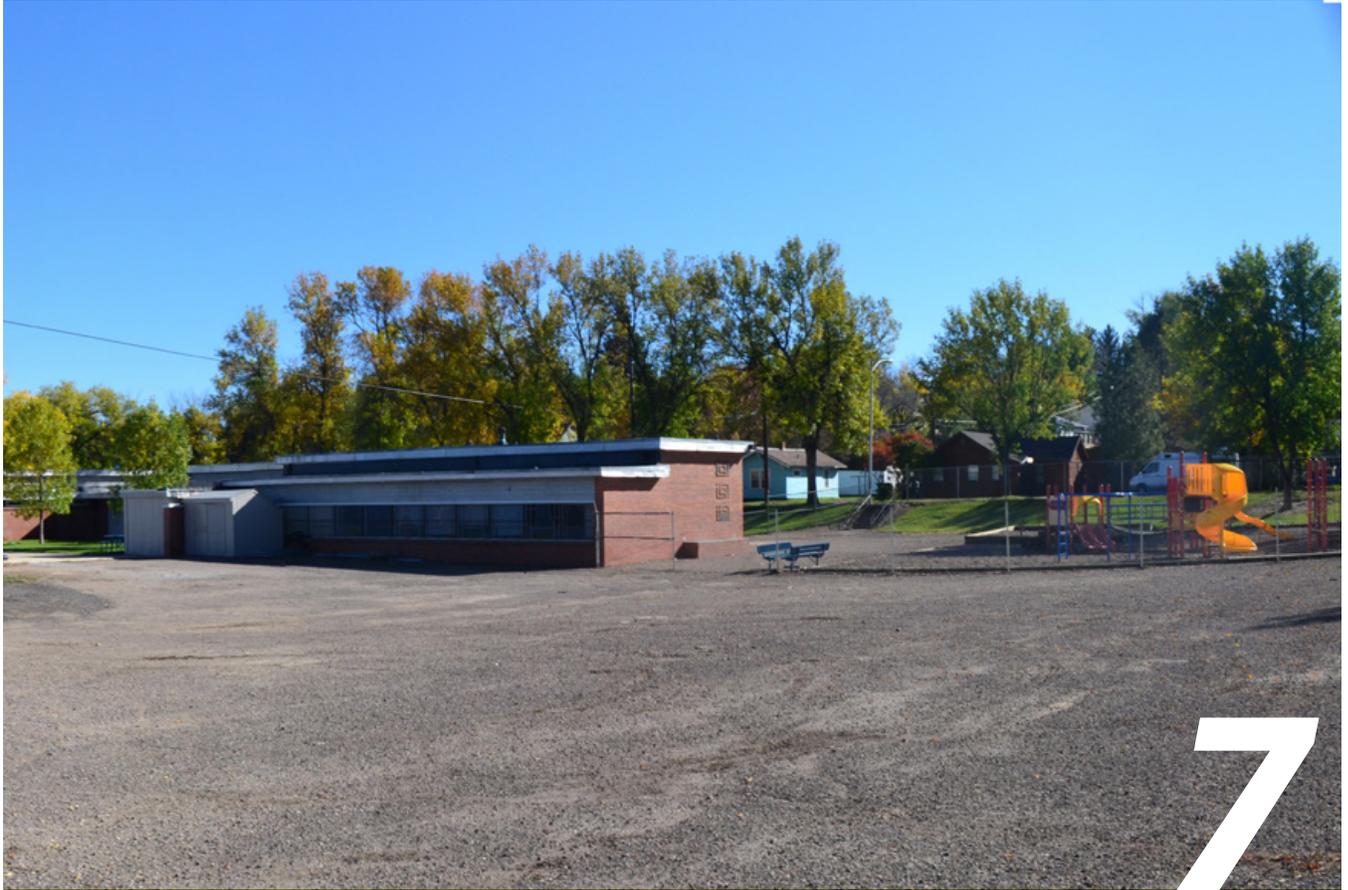
**Site Improvements**

Provide accessible routes to the playground. The new playground is accessible, but there are challenges with accessing it from the building.

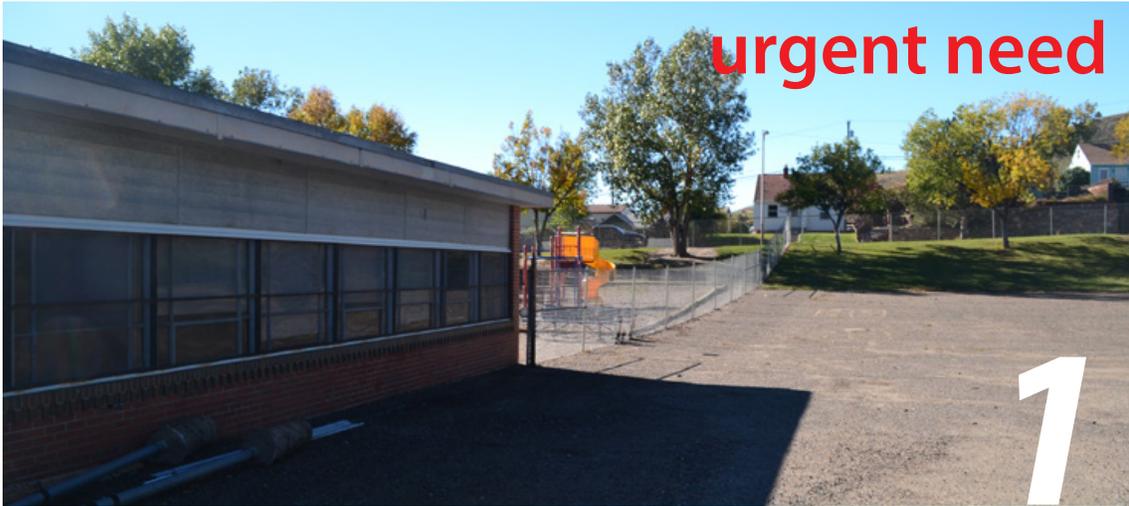
**Re-roof STEM / Power Hour space**

urgent need

Remove the existing roofing and insulation. Replace with new insulation that meets energy standards. The roof will be replaced with a new roofing membrane system, with new flashing and trim. Any roof drainage issues will be mitigated.

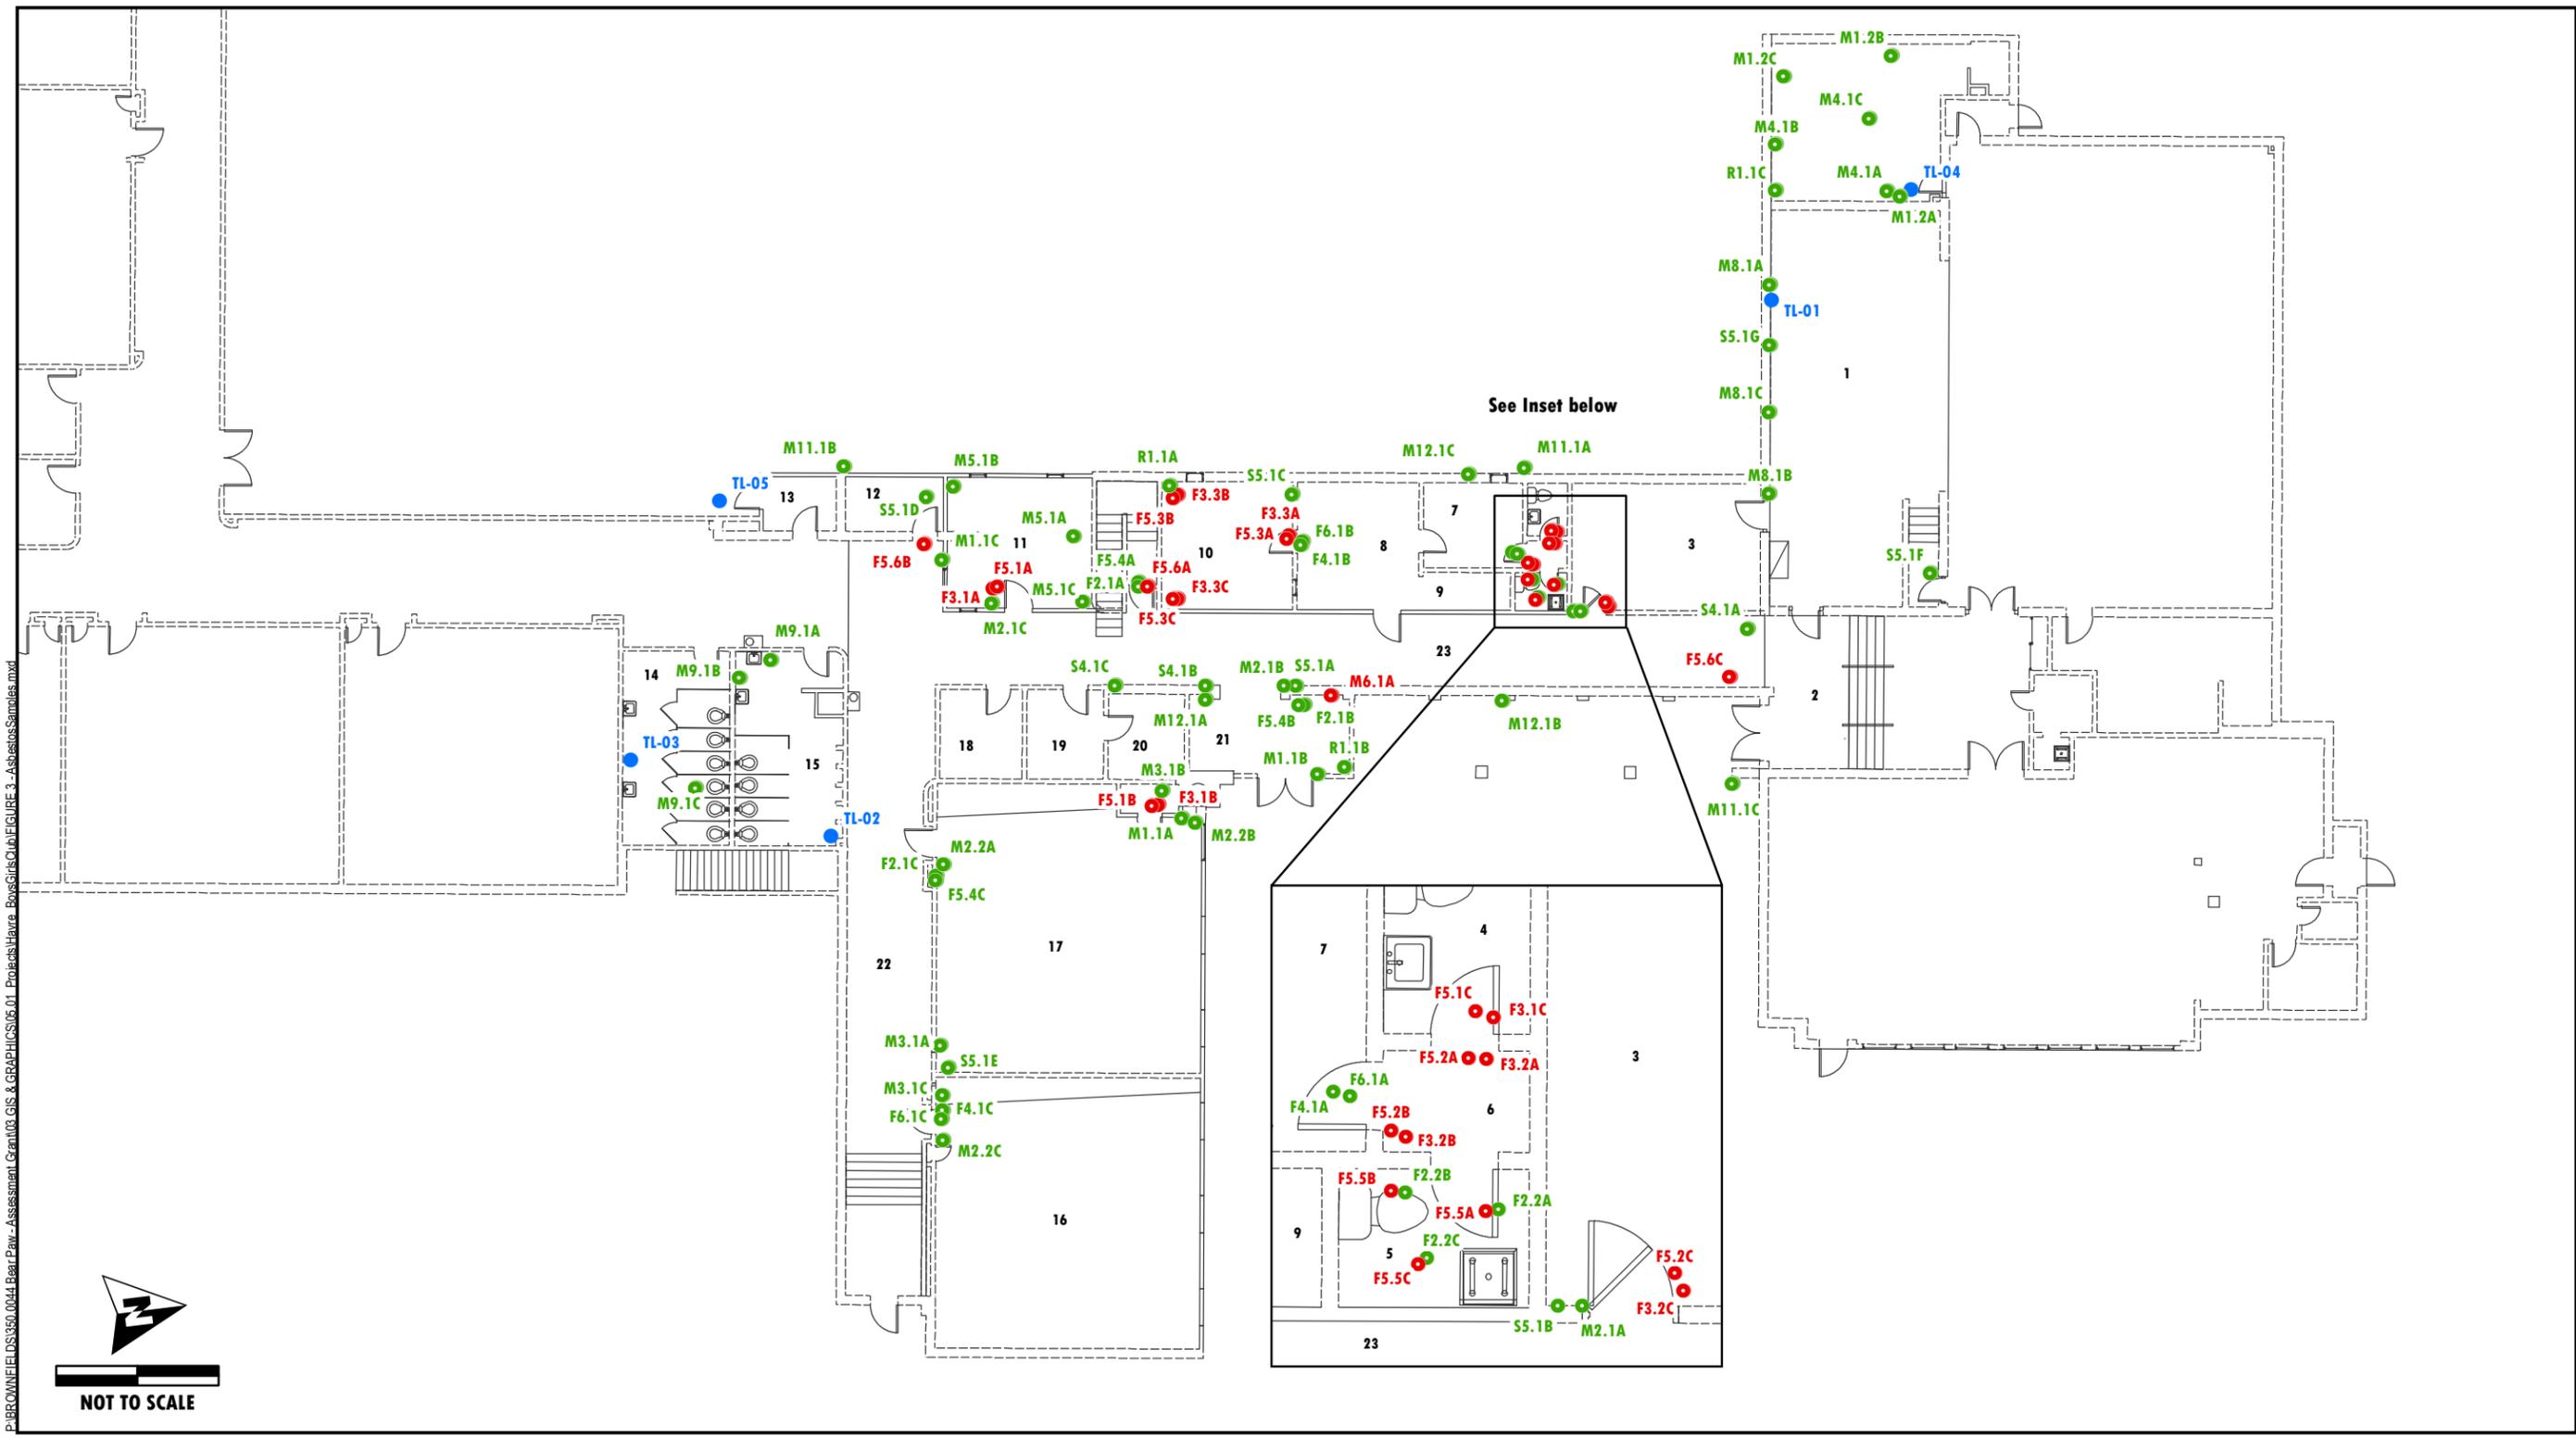
Asbestos Samples  
 Boys and Girls Club  
 Havre, Montana  
 FIGURE 3

The asbestos analytical report, including a description of each building material sample, sampling location, and analytical result is provided in **Appendix F**. Sampling locations and results are summarized in **Figure 3**. Based on laboratory results, nine samples from six types of building materials contained greater than one percent (>1%) asbestos, as shown in **Table I**. Results for the remainder of the building materials were non-detect for asbestos (**Appendix F**).

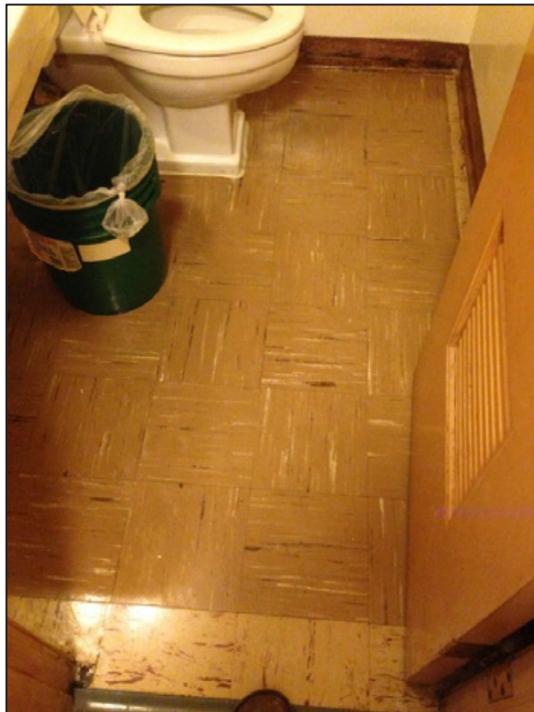
**Photo 6:** 9-inch Vinyl Floor Tile (VFT) in small restroom.

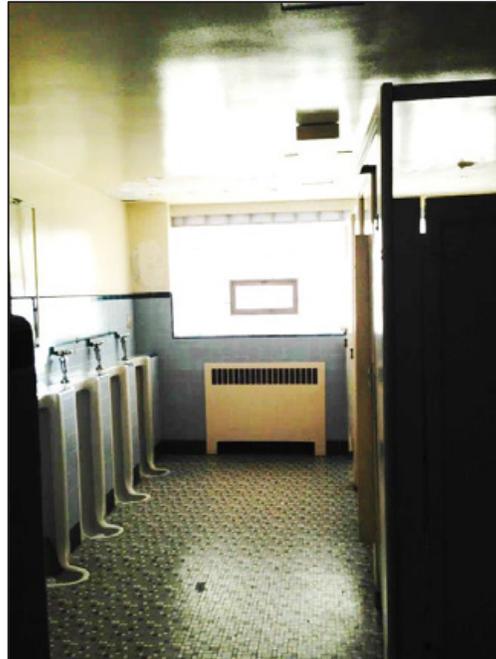
**Photo 9:** Ceramic tile in boy's restroom.
